January 29, 2003

Subject: Contract DTRS57-99-D-00017, Task Order C0023
U.S. EPA Region 8, Asbestos Project - Emergency Response
Libby Sister Site Field Sampling Activities at
Former Vermiculite Intermountain Facility - SLC2
333 West 100 South, Salt Lake City, UT
Summary Report (Revision 1)

Figure 1. Site location map of SLC2

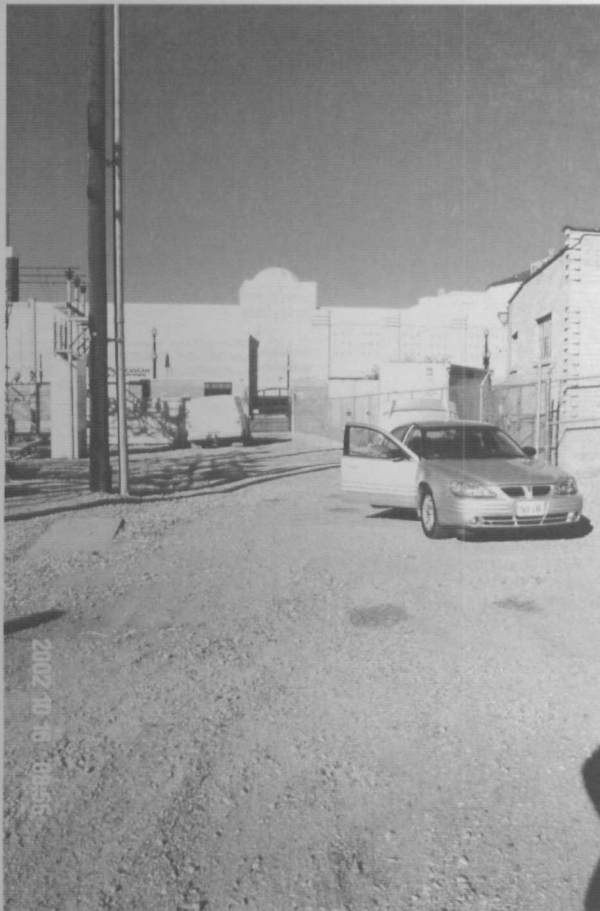
Photo 2. Photograph facing west showing the location of former railroad spur that supplied vermiculite to former processing plant.

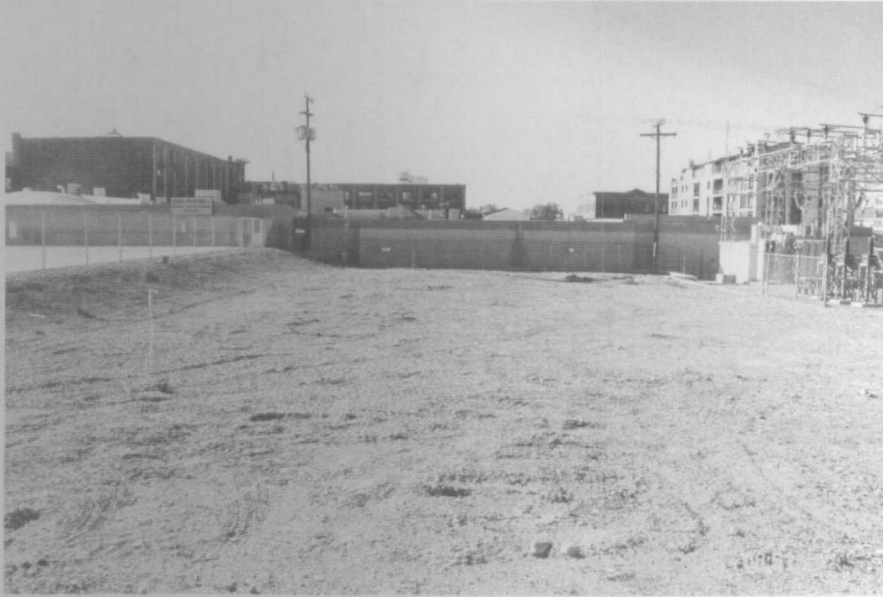
Photo 3. Photograph facing south showing site of former processing plant (SLC2).

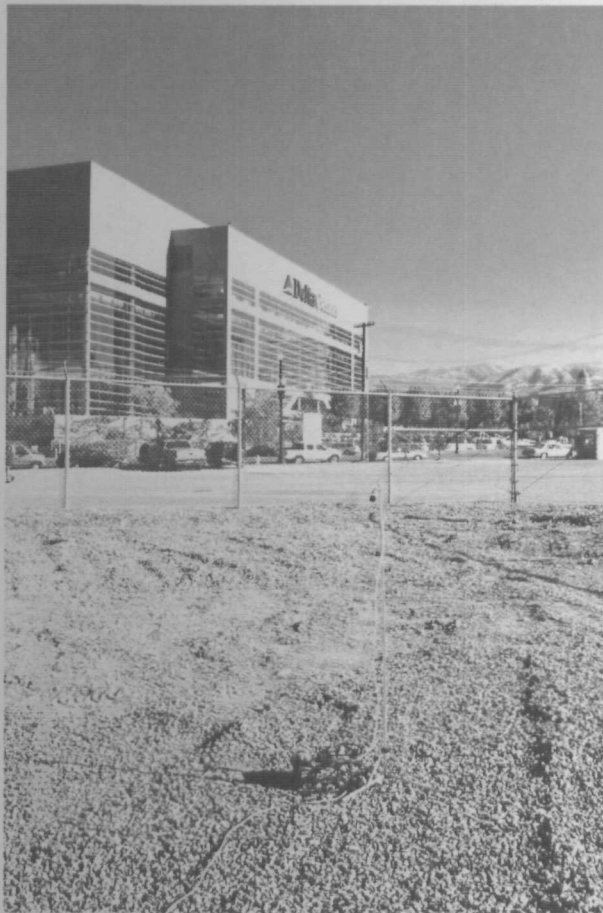
Photo 4. Photograph facing northeast showing air monitoring station S008 in foreground. Note Delta Center in background.

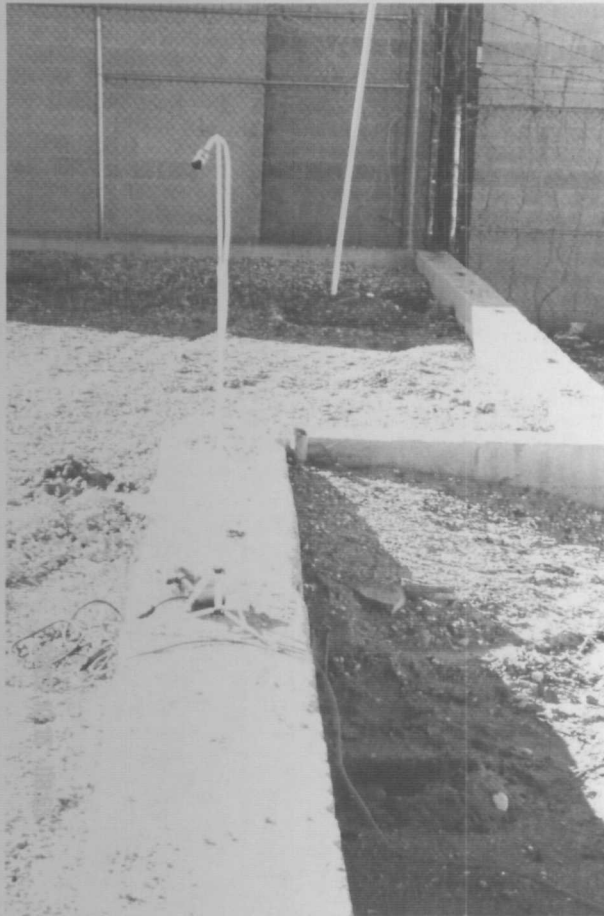
Photo 5. Photograph facing south showing remaining foundation from former processing plant. Note air monitoring station S006 on wall.

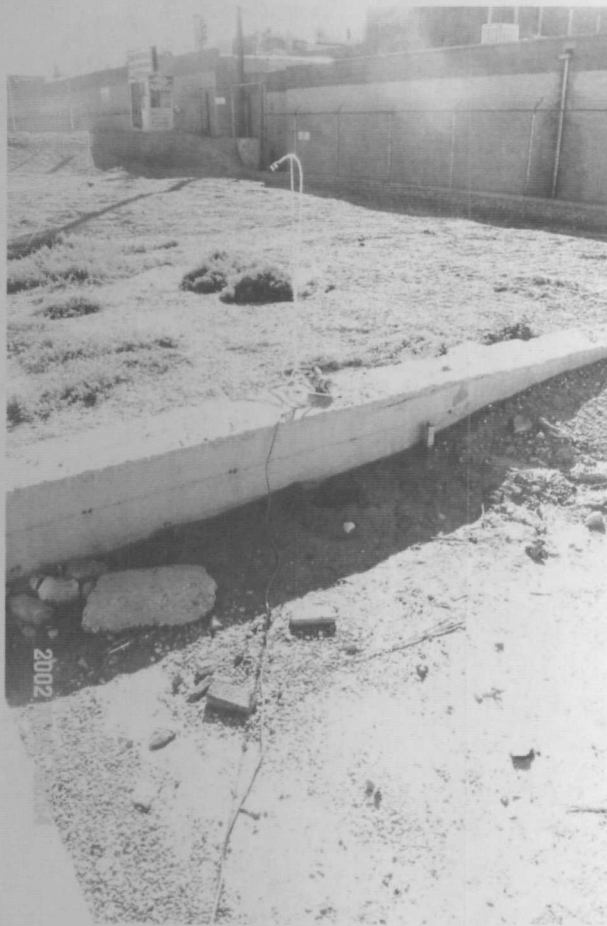
Photo 7. Photograph facing southwest showing air monitoring station S006. Note vermiculite product in foreground.
